**DEPARTMENT OF TRANSPORTATION****DIVISION OF ENGINEERING SERVICES**

Contract #: 04-0120F4Cty: SF/ALA Rte: 80 PM: 13.2/13.9File #: 69.28**WELDING INSPECTION REPORT****Resident Engineer:** Pursell, Gary**Address:** 333 Burma Road**City:** Oakland, CA 94607**Report No:** WIR-000348**Date Inspected:** 06-Aug-2007**Project Name:** SAS Superstructure**OSM Arrival Time:** 800**Prime Contractor:** American Bridge/Fluor Enterprises, a JV**OSM Departure Time:** 1530**Contractor:** Zhenhua Port Machinery Company, Ltd (ZPMC), Changxing Island **Location:** Shanghai, China**CWI Name:****CWI Present:****Yes No****Inspected CWI report:** **Yes No N/A****Rod Oven in Use:** **Yes No N/A****Electrode to specification:** **Yes No N/A****Weld Procedures Followed:** **Yes No N/A****Qualified Welders:** **Yes No N/A****Verified Joint Fit-up:** **Yes No N/A****Approved Drawings:** **Yes No N/A****Approved WPS:** **Yes No N/A****Delayed / Cancelled:** **Yes No N/A****Bridge No:** 34-0006**Component:****Summary of Items Observed:**

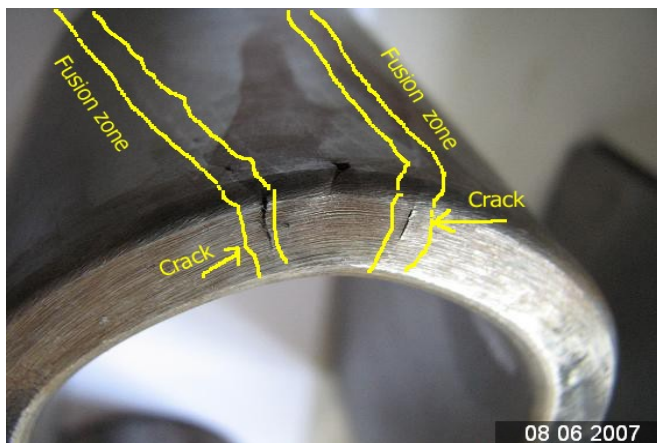
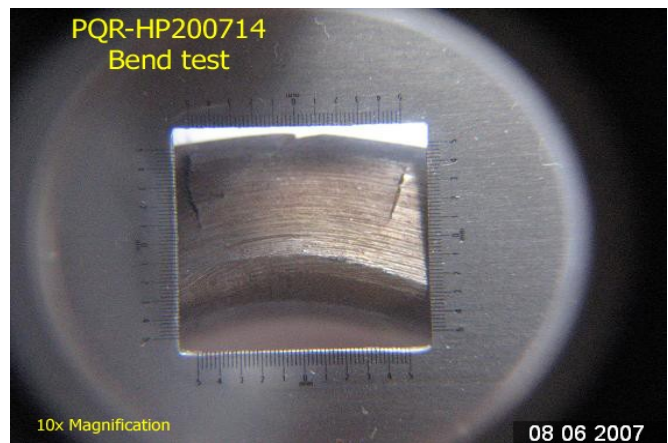
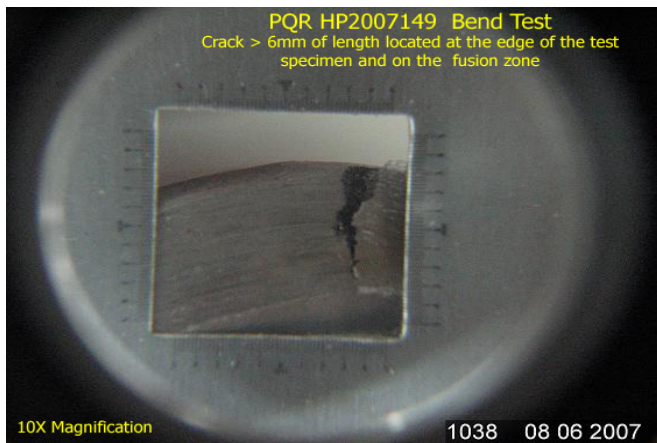
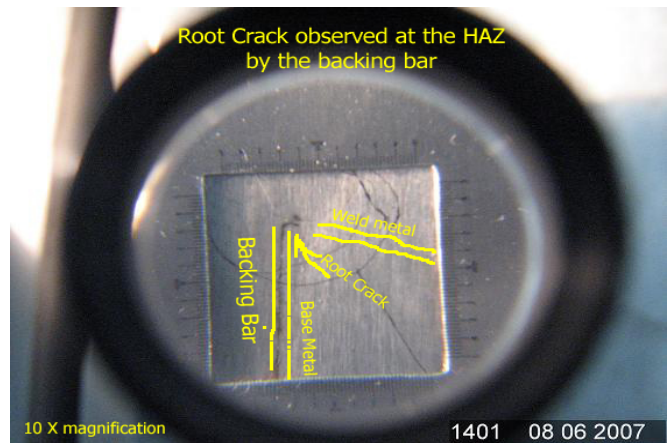
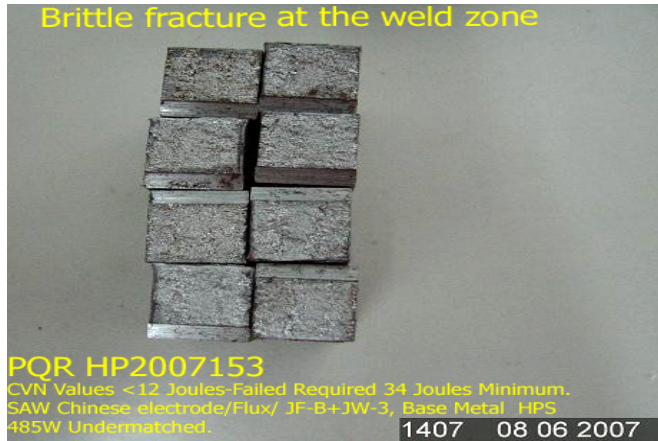
The QA inspector observed cracking on the fusion zone on four specimens for the PQR HP2007149 after bending. The QA inspector had a conversation with ABF representative Kevin Dye and ZPMC representative Huang Wei. The QA inspector brought to the attention of Mr. Huang and Mr. Dye that the four (4) bend test specimens for the PQR-HP2007149 had root cracks at the edge of the fusion zone. Mr. Wei and Mr. Dye agreed with the QA inspector and proposed that two additional bend specimens to be tested. The QA inspector had a conversation with the Caltrans Task Leader Dave McClary. The QA inspector brought to Mr. McClary attention that the bend test for the PQR HP2007149 had four specimens with similar pattern of root cracks on the fusion zone and ZPMC and ABF representatives were proposing to bend 2 additional specimens as resolution. Mr. McClary, Caltrans Structures representative Keith Devoport and Caltrans Senior Level III John Kinsey went to the ZPMC test lab area. After performing visual observations on the test coupons, Mr. McClary and Mr. Devoport brought to QA inspector attention that a macroetch test specimen showed a root crack and appeared to be the cause of the after

bending cracking at the fusion zone . Mr. McClary added that Caltrans representatives were going to bring to ABF representatives attention the condition of the bend and macroetch tests for the PQR HP2007149. The QA inspector observed ABF representatives Craig Knops and Steve Lawton performing visual observations to the test specimens for the PQR HP2007149. The PQR HP2007149 results were still pending at the end of the shift.

The QA inspector witnessed the CVN testing for the above mentioned PQRs. The QA inspector observed that CVN test values from the specimen designated as PQR HP 2007153 were below the minimum required by the AWS D1.5 for fracture critical material at - 30 degree Celsius. The actual values were below of 12 Joules and the minimum required CVN value was 34 Joules for the under matched joint A709 grade 345 to HPS 485 grade 485W material. Mr. Huang relayed to the QA inspector that the ZPMC rejected the PQR HP 2007153 due to the actual CVN values obtained were below of the minimum required value. See TL\_6032 for details of this test.

The digital photographs below show the CVN test coupons after testing for the PQR-HP 2007153 and the Macroetch and bend test result for the PQR-HP2007149.
